## **Historic Paint Finishes Report:**

Elk Landing: The Hollingsworth House Elkton, Maryland

The Original Finishes of the First Floor Rooms and the Exterior

Date: 2 February 2004

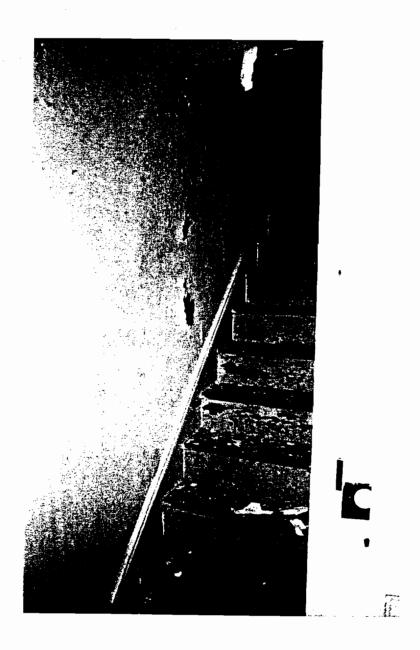
## On- site photograph Back Hall: Stair case

Note: The treads of the stair case have been replaced, however, the risers appear to have the moderate pinkish brown finish color that is seen on the other woodwork.

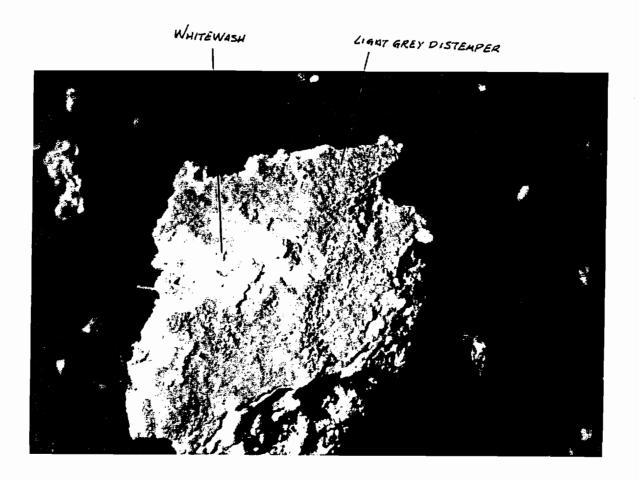
Back Hall: Sample BH-6: Wall plaster

Note: The view of the sample is looking down onto the finish surface. The plaster substrate is clearly seen, supporting a lime whitewash finish, and a later light grey distemper finish.

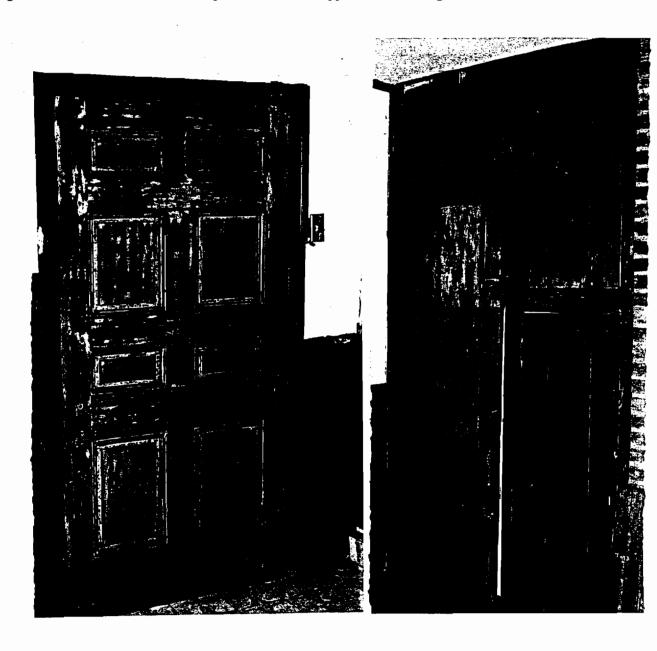
## On- site photograph Kitchen: Door to the exterior and Doors, north of fireplace

Note: The door to the lower porch shows remains of an oak graining similar to that seen in the Dining Room. The doors north of the fireplace have been stripped but were not grained.
